# **PARTIAL DISCHARGE EVALUATION OF A HIGH VOLTAGE TRANSFORMER**

**Magister Technologiae: Engineering: Electrical**

**February 2015**

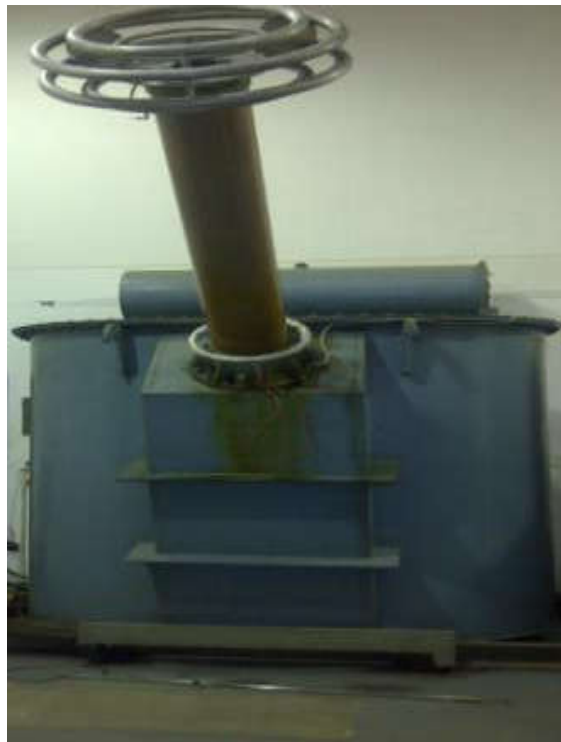
**Figure 13:** A photograph of 400 V/300 000 V single-phase transformer

Most serious failures of HVT are due to insulation (paper) deterioration leading to a breakdown. The 400 V/300 kV single-phase transformer in the high voltage laboratory of VUT was manufactured in 1967 and the operating conditions prior to 1995 are not known. This is because no formal documentation on operating conditions are available and no maintenance and diagnostic test methods such as PD measurements have been carried out to assess the condition of the insulation of the transformer to ensure its reliability and safety in the laboratory.

Terms	HV Transformer
Age	46 years old
kVA	200
Volts (HV)	300 000
Volts (LV)	400
Amps (HV)	0.667
Amps (LV)	500
Frequency	50 Hz
Manufacturer	Foster Transformers Ltd.

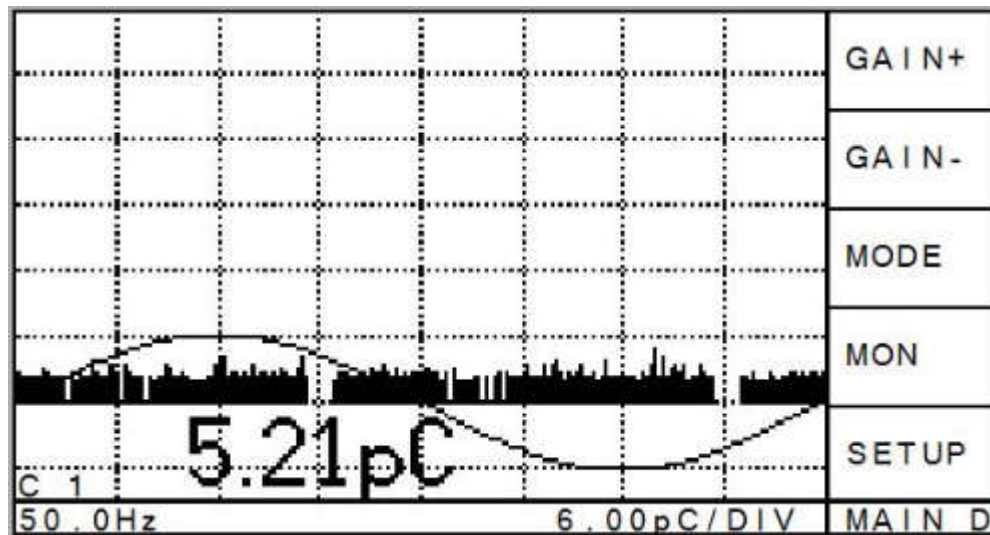
**Figure 20:** Noise recorded initially

Figure 20 shows the background noise recorded at the initial stage when the system was energised for the first time. The magnitude was recorded as 5,21 pC and Figure 12 shows the measuring circuit used.

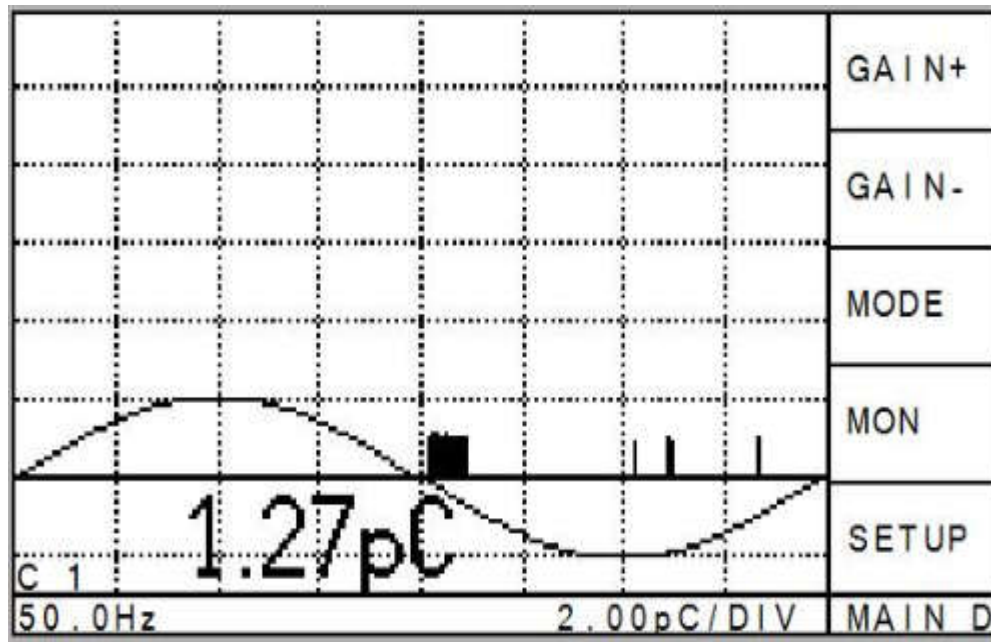
**Figure 23:** Background noise recorded after the isolator transformer was connected

Figure 22 shows the circuit diagram of the screen isolator transformer connected to the measuring device. The background noise drastically reduced from 5,21 pC to 1,27 pC as shown in Figure 23.

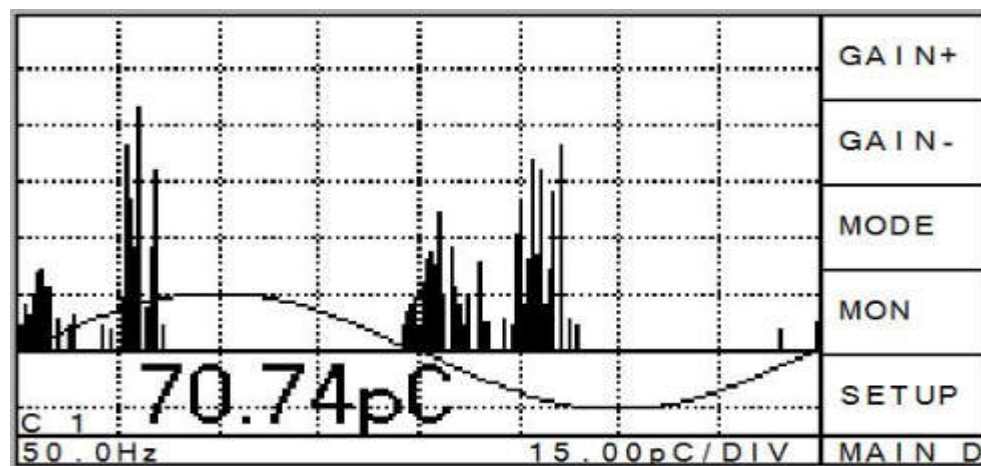
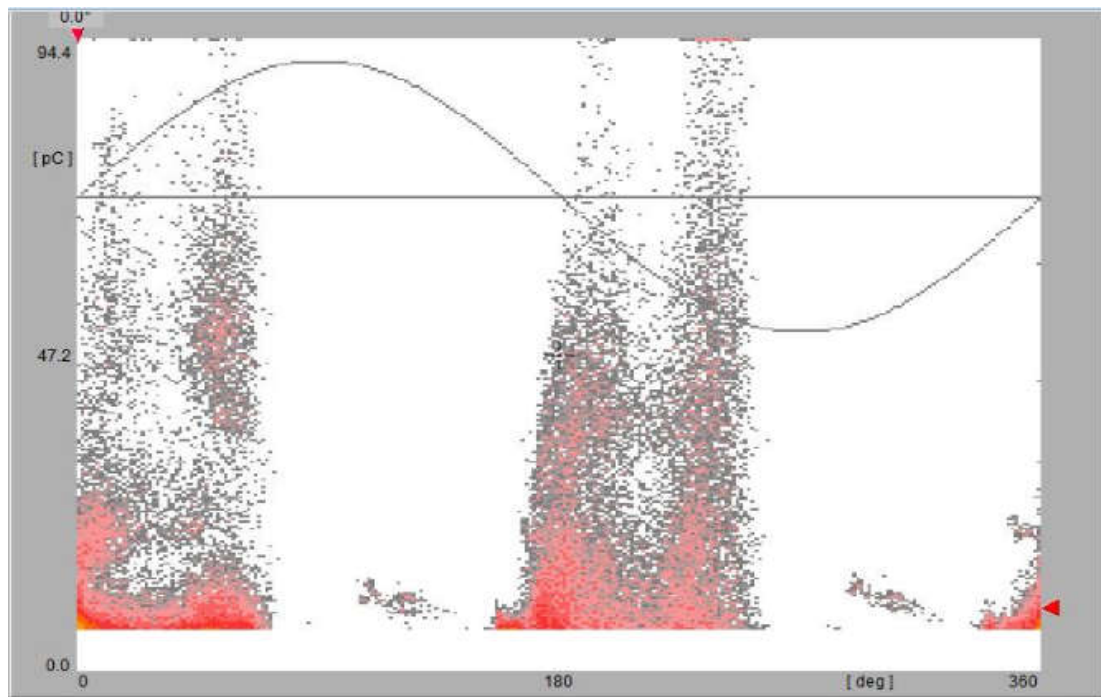
**Figure 25:** Typical  $\Phi$ - $q$  patterns for a 300 kV transformer

70,74 pC at 70 kV

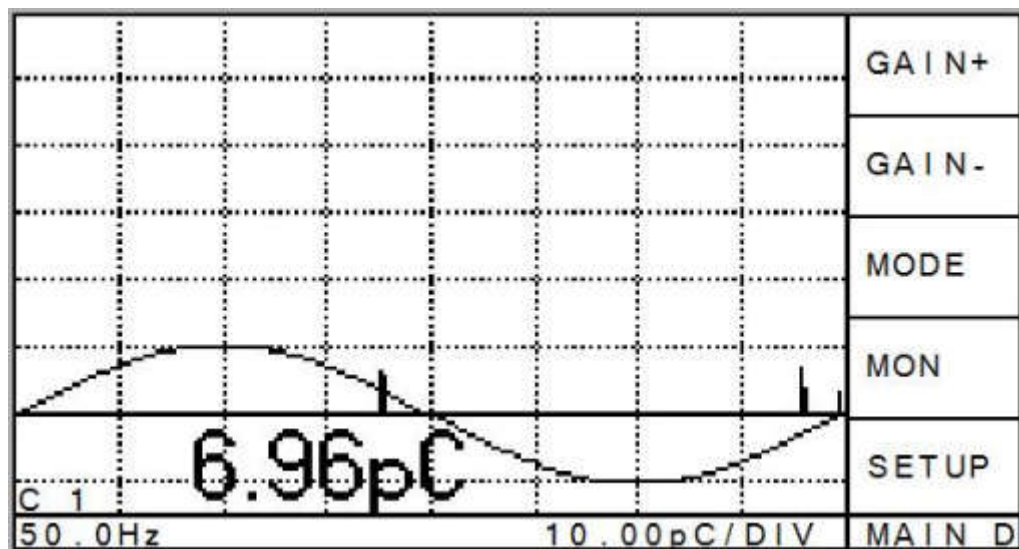
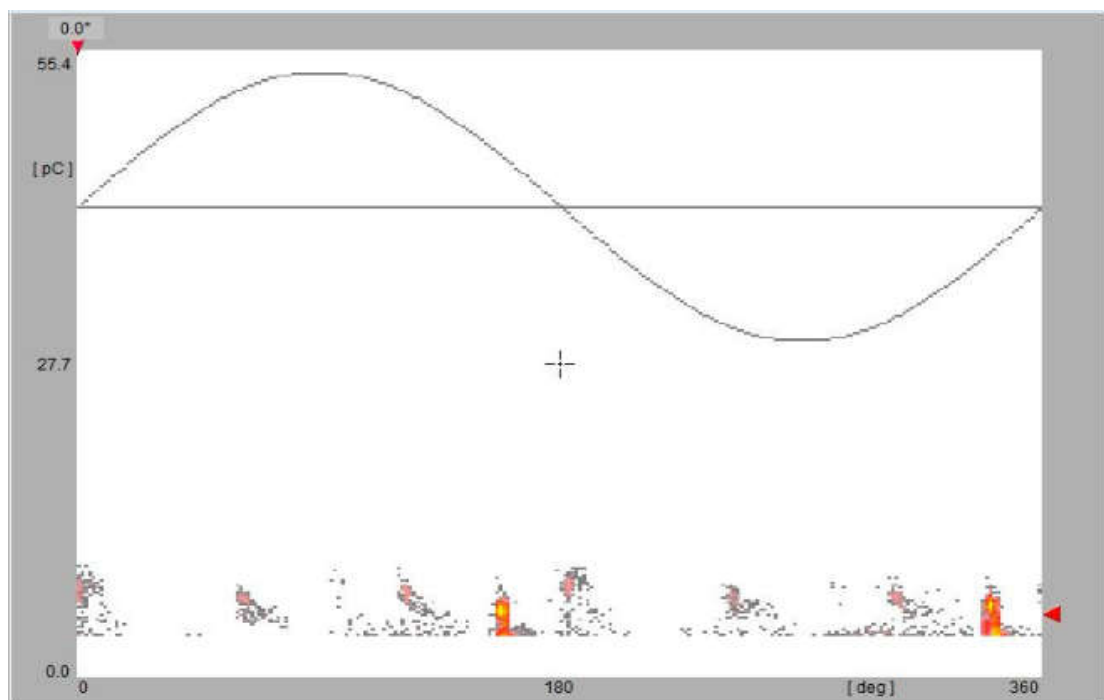
**Figure 28:** Partial discharge pulses recorded from the measurement of a 300 kV transformer

6,96pC at 70 kV

6,96 pC at 70 kV

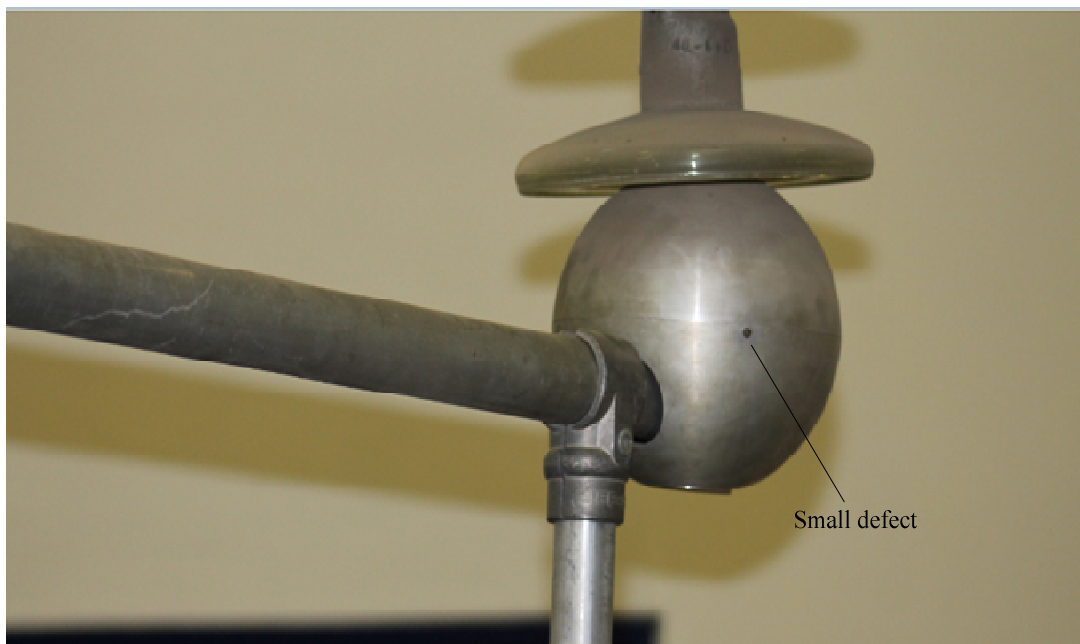
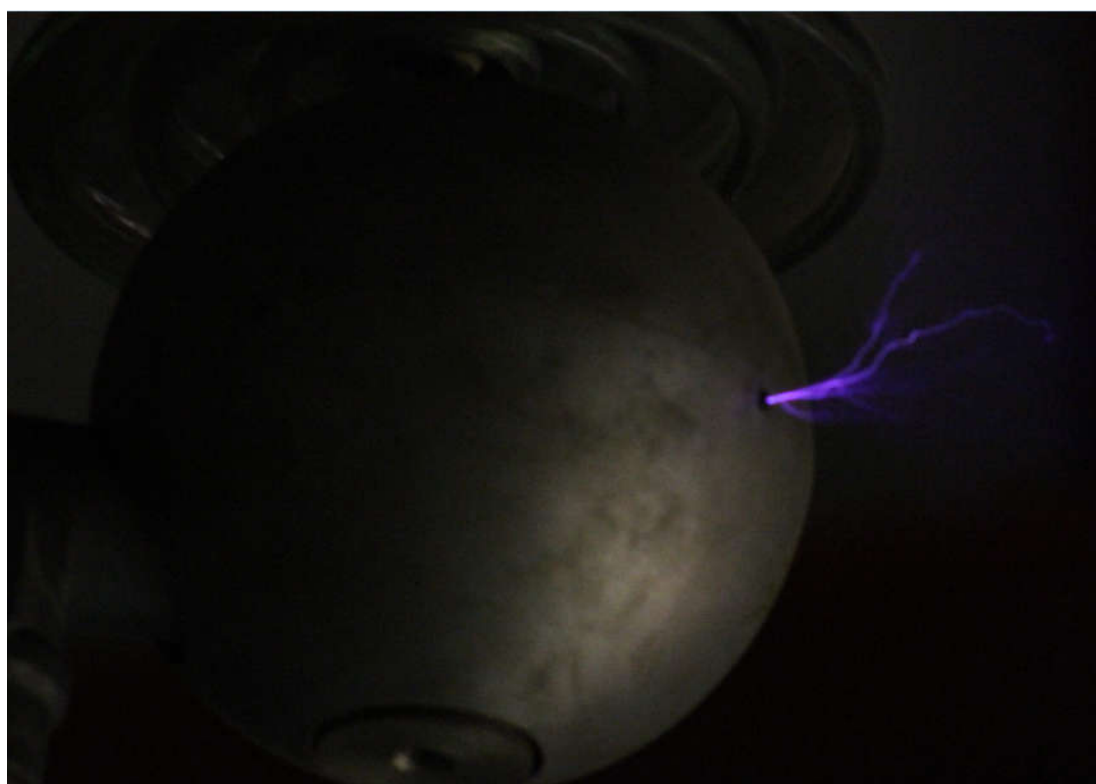
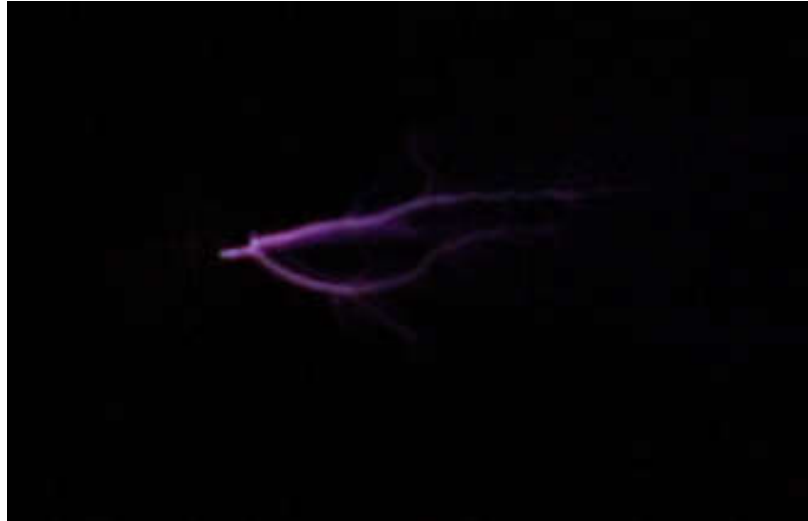
The setup was energised and the voltage was increased in steps from 10 kV to 150 kV. Nothing recorded at this stage. The aim was to check the setup to see if the connections were done properly. The voltage was then raised further above 150 kV and continuous corona discharges occurred, which resulted in arcing from the sphere connector. Figure 32 shows the arcs from the sphere.

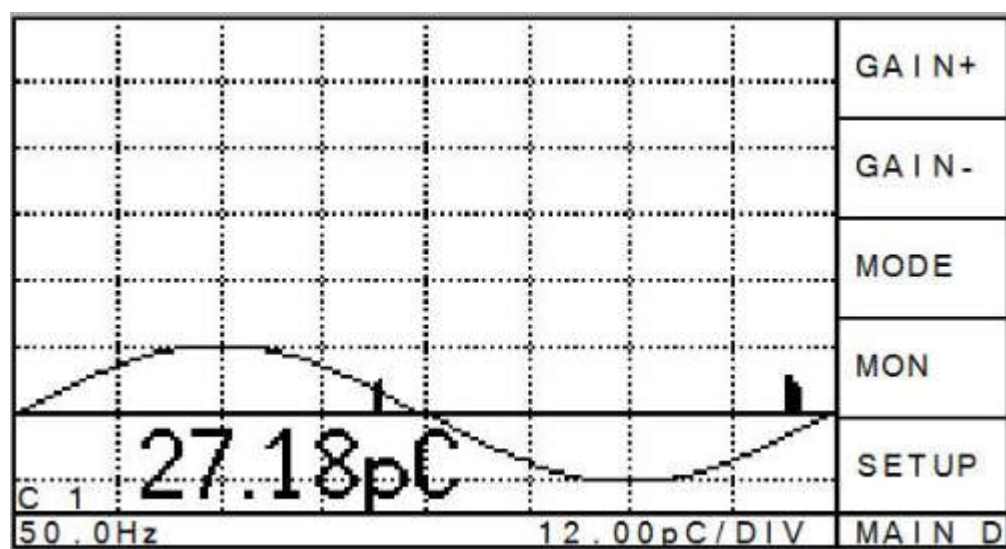
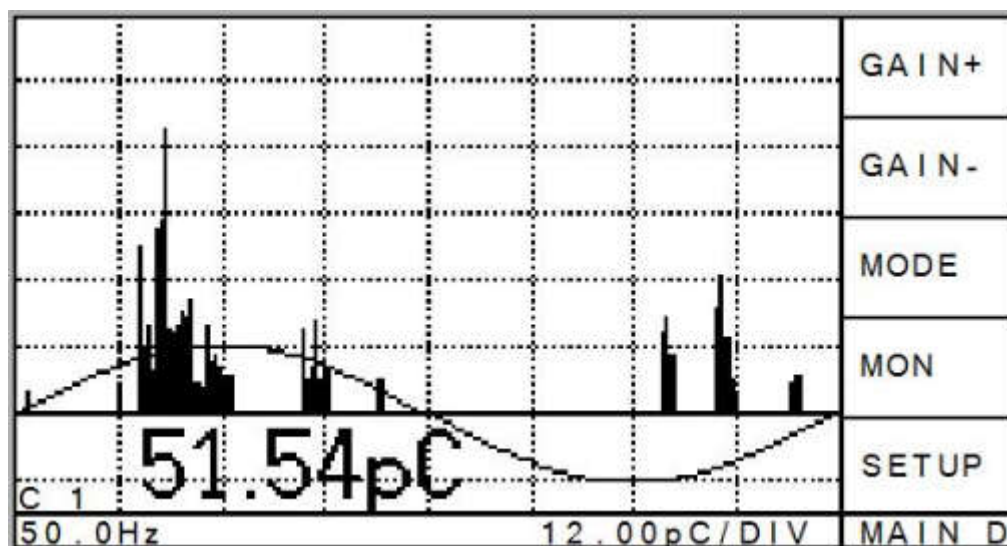
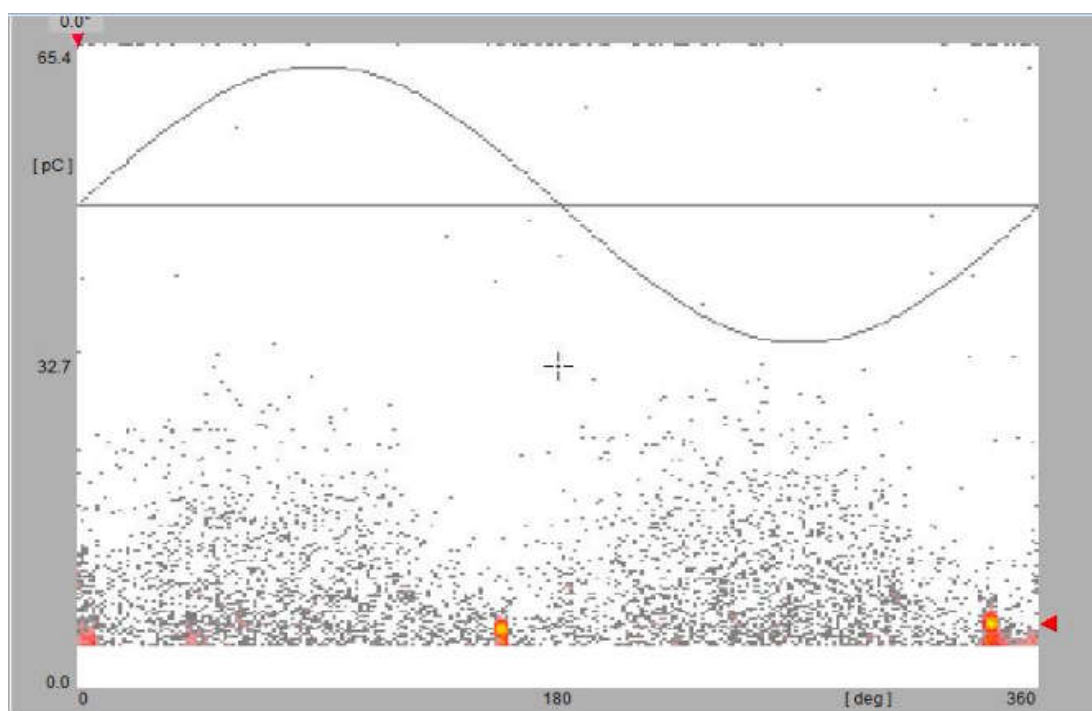
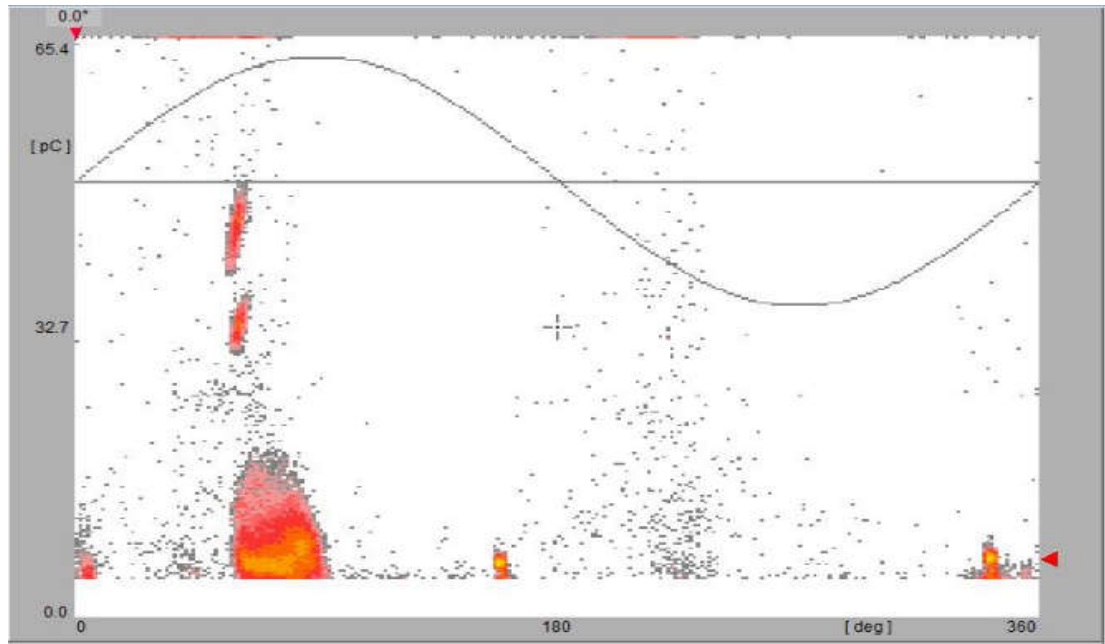
**Figure 34:** Partial discharge pulses recorded from the measurement on a 300 kV transformer

(a) 27,18pC at 190 kV

(b) 51,54pC at 200 kV

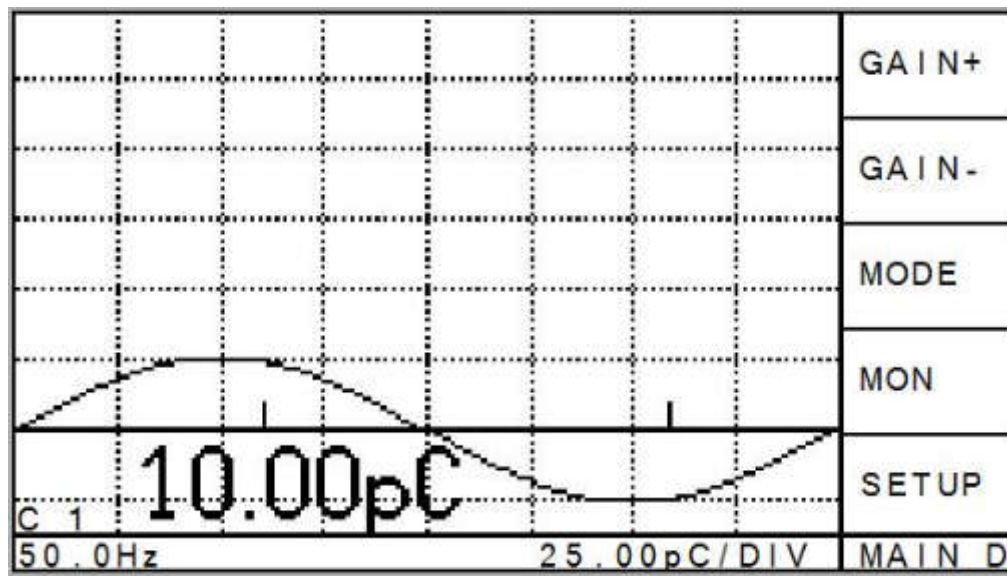
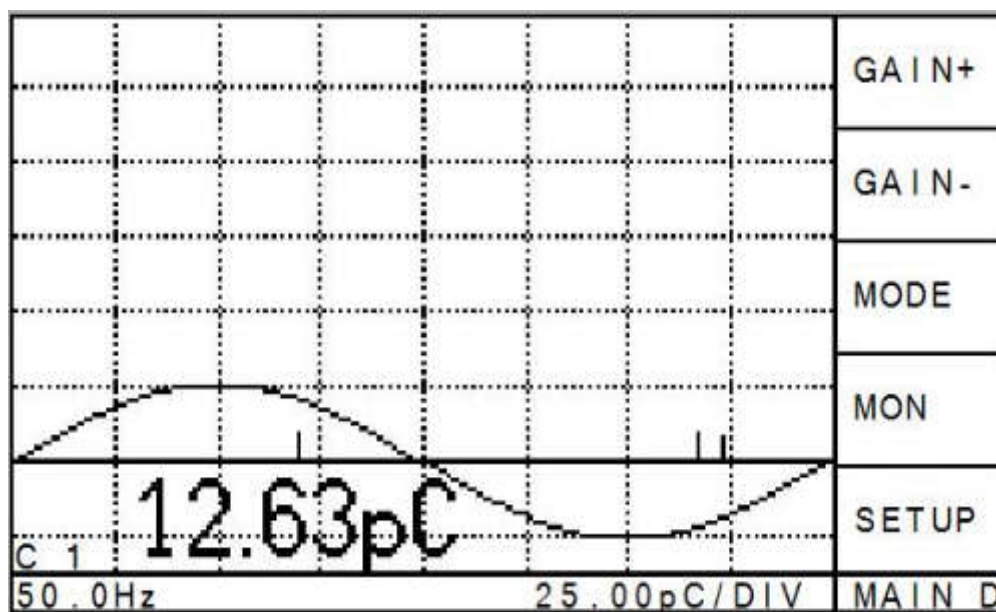
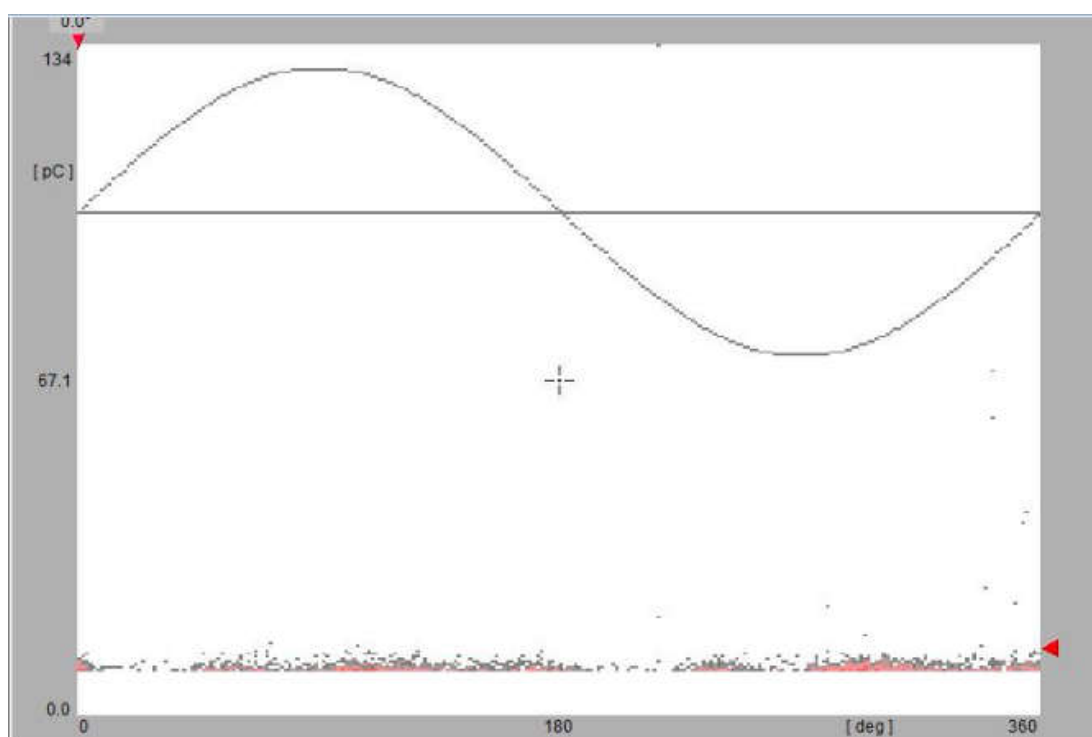
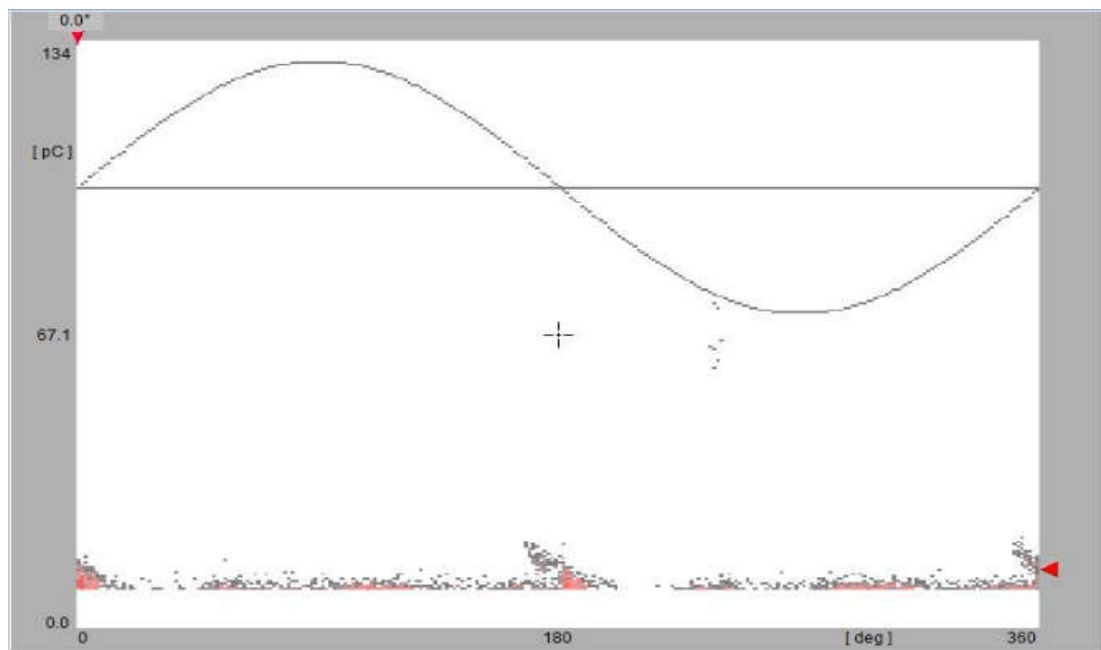
**Figure 38:** Partial discharge pulses recorded from a 300kV transformer

(a) 10,00 pC at 200 kV

(b) 12,63 pC at 250 kV

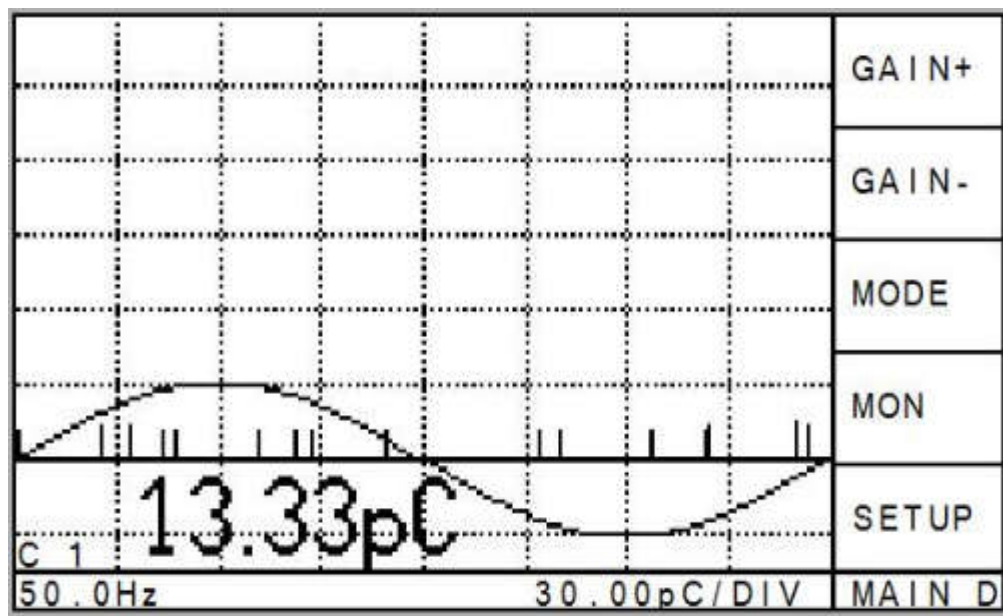
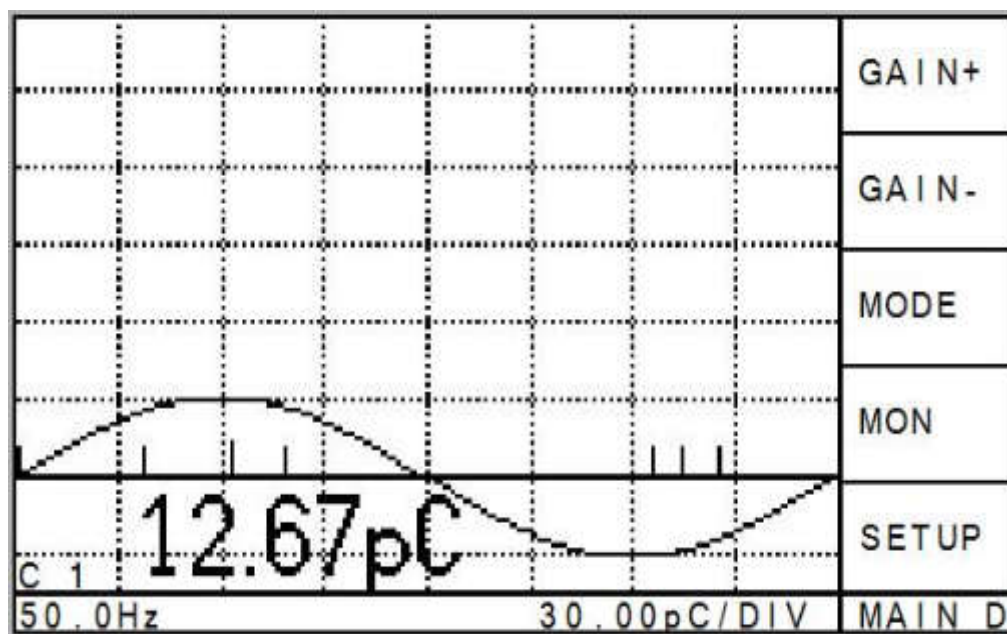
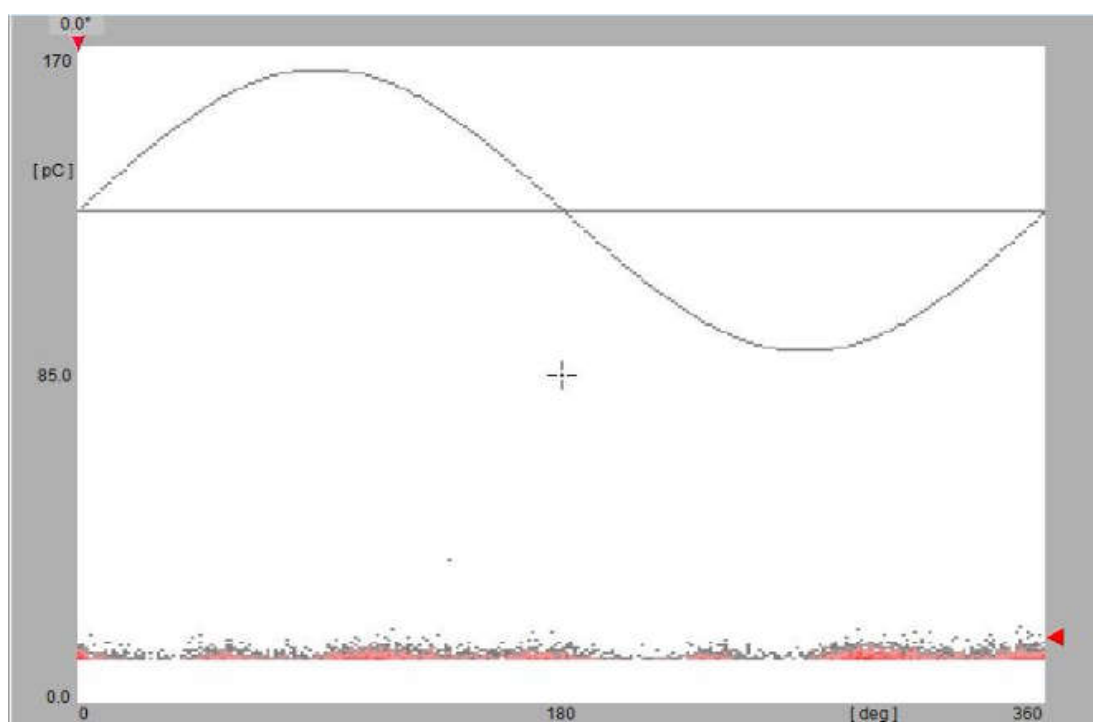
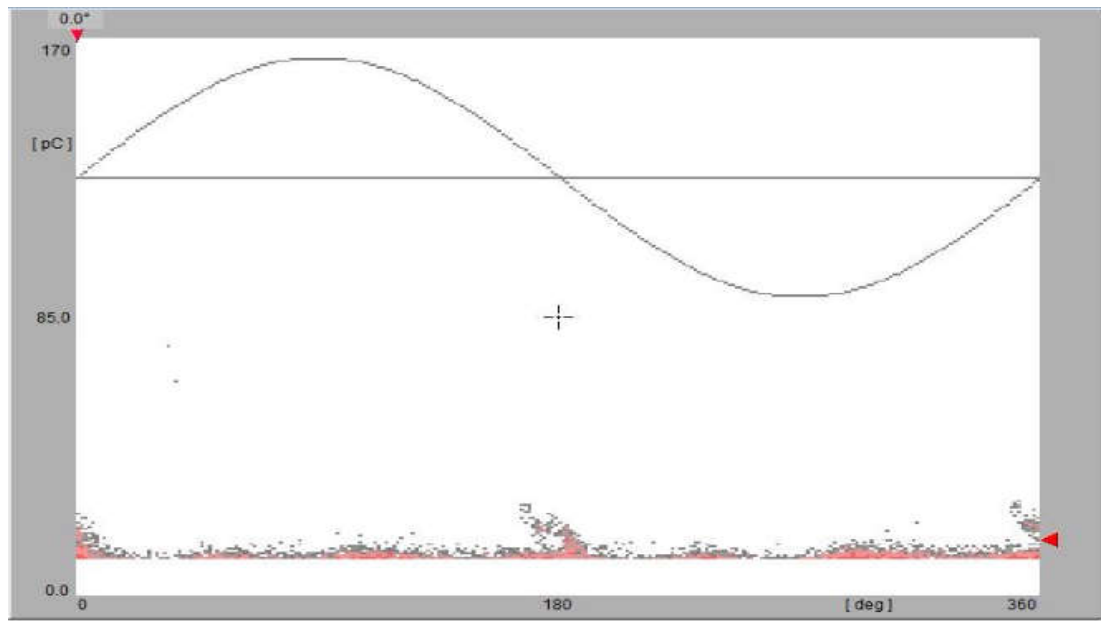
**Figure 41:** Partial discharge pulses recorded from a 300kV transformer

(a) 13,33 pC at 200 kV

(b) 1267 pC at 250 kV

(b) 12,67 pC at 250 kV
