DEVELOPMENT OF PAVEMENT MANAGEMENT SYSTEM FOR ROAD NETWORK MAINTENANCE

VAAL UNIVERSITY OF TECHNOLOGY

DEPARTMENT OF CIVIL ENGINEERING

MASTERS OF TECHNOLOGY RESEARCH DISSERTATION

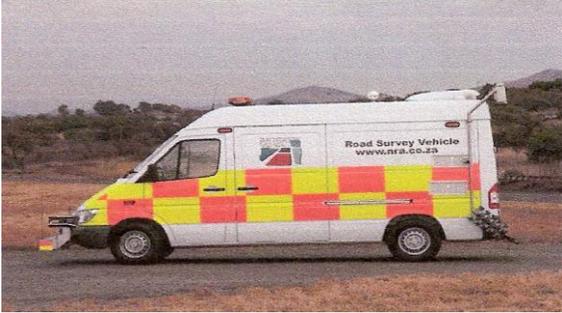
Picture 2.1: SANRAL Road Survey Vehicle
(Source: SANRAL 2006:5)

RSV, as shown on Picture 3.1, uses the latest technology and records, traffic and weather permitting, various road characteristics (condition data) whilst moving along with the traffic stream at speeds between 20 to 120 kilometres per hour (km/h). Data can be collected on over 500 lane km per day per RSV. The digital electronic components used by the vehicle includes

numerous lasers, accelerometers, gyro's, different GPS, Digital Video Systems (DVS), distance measuring instruments and power supply systems.

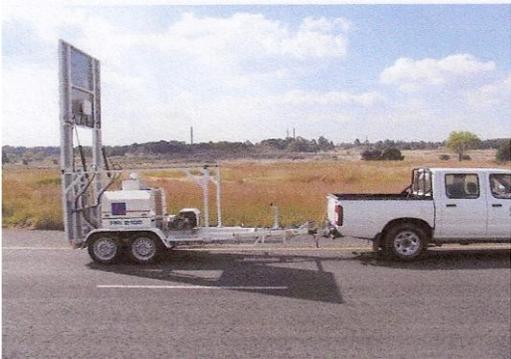
Picture 2.2: Falling Weight Deflectometer **Figure 2.1:** Schematic Illustration of FWD
(Source: SANRAL 2006:7) (Source: SANRAL 2006:7)

FWD refers to a trailer mounted device as seen in Picture 3.2 and Figure 3.1 that simulates the effect of moving heavy vehicle wheel load (80 km/h) by applying a dynamic impulse load to the pavement, and then measuring the subsequent deflections that occur at various radial distances from the load centre to provide a deflection bowl.

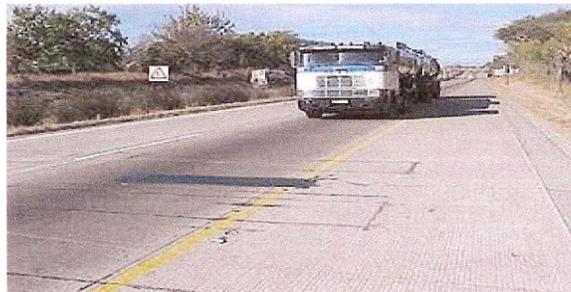
Figure 2.3: Traffic Monitoring Station
(Source: SANRAL 2006:8)

TMS are electronic monitoring equipment that makes use of induction loops and other sensors installed in the road surface to monitor the movement of vehicles. Depending on the sensors used this enables us to determine down to five minute intervals how many of which vehicle class past the measuring point, their speed, their following distance and even weight on each axle. TMS is shown on Figure 3.3.

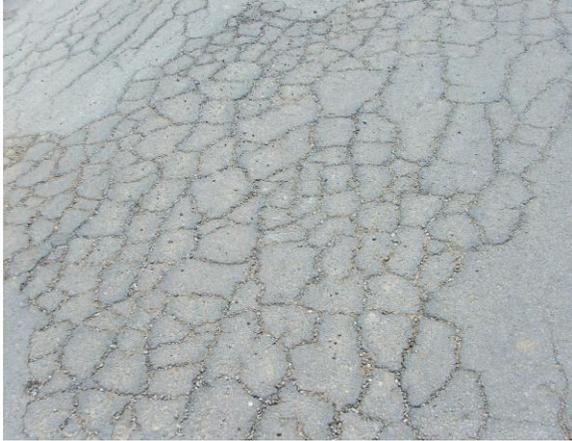
A1: Crocodile Cracks

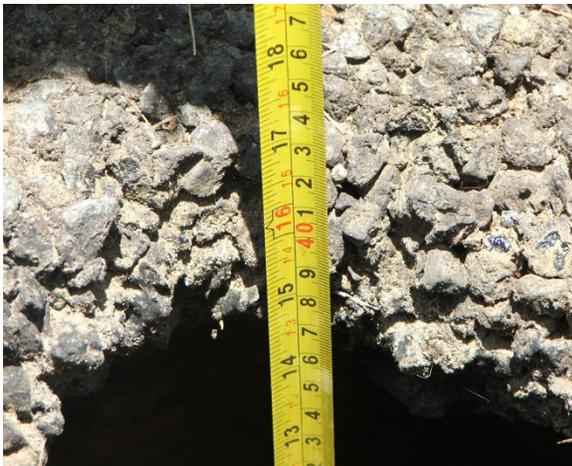
A3: 150mm Deep Pothole

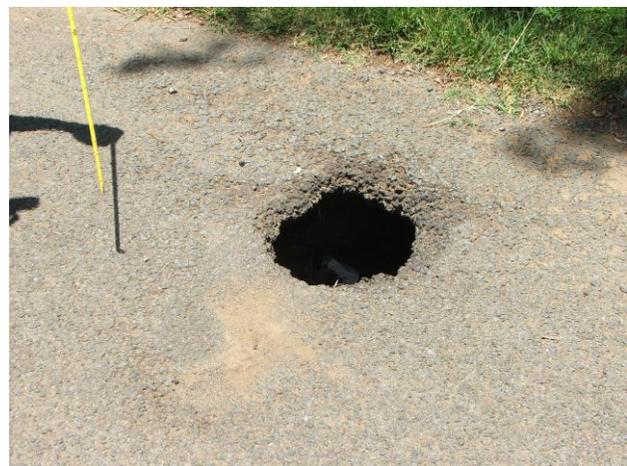
A4: Potholes

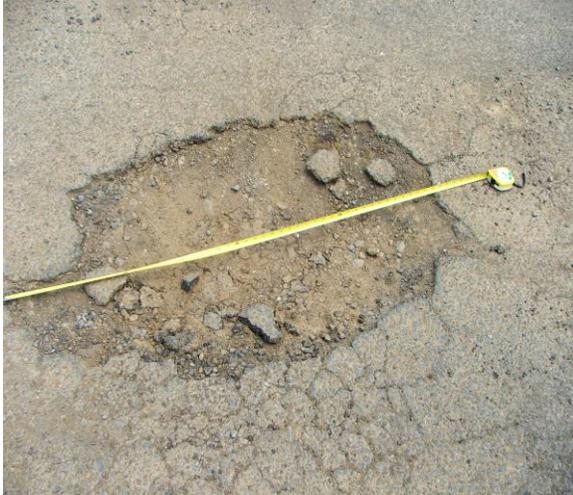
A5: Surface Failure

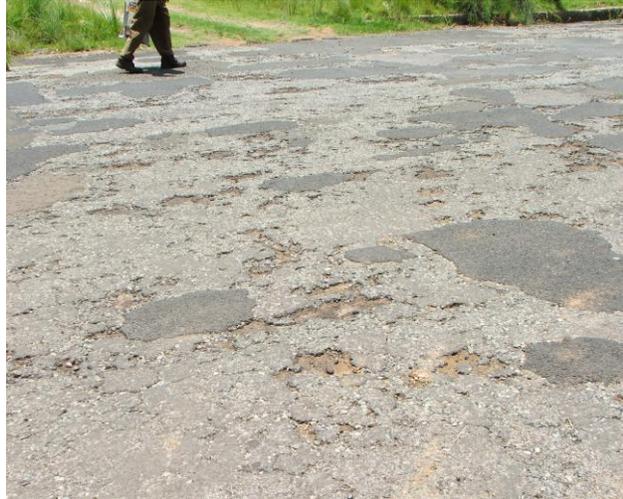
A6: Patching
