# **PARTIAL DISCHARGE EVALUATION OF A HIGH VOLTAGE TRANSFORMER**

**Magister Technologiae: Engineering: Electrical**

**February 2015**

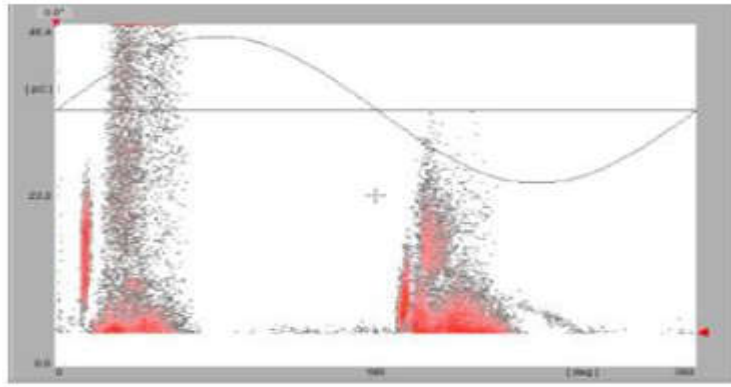
46,4 pC at 10 kV

**Figure 15:** PRPD pattern measured on an 11 kV VT

Figure 15 shows PRPD patterns of cavity discharge in the insulation of the high voltage winding when the low voltage winding and core are grounded and HV sides are connected to the coupling capacitor as shown in Figure 14. When the applied voltage is higher, the numbers of partial discharges per cycle, the total charge per cycle and the maximum magnitude of the cavity discharge are higher.

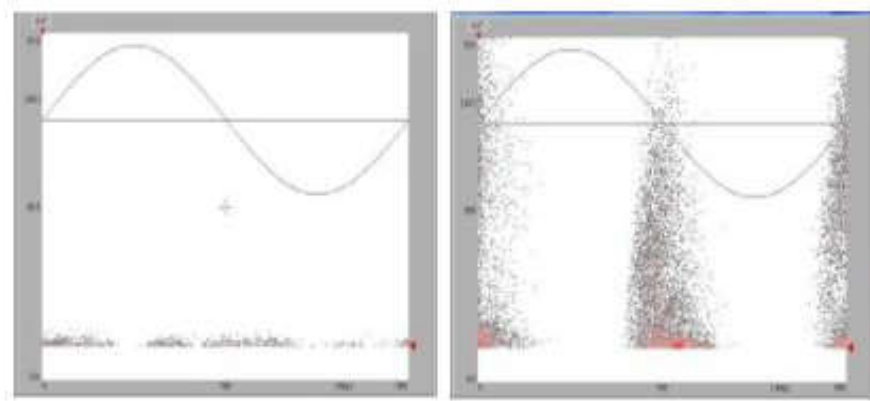
(a) 5.2 pC at 10 kV

**Figure 17:** Partial discharge pattern measured on an 11 kV VT

Figure 17 shows the discharge patterns when the transformer was excited from the high voltage winding as shown in Figure 16. There were no significant discharges

The reason why the discharges occurring when the connections shown in Figure 14 did not appear during the second test (Figure 16) can be that the defect is in the high voltage insulation at the end of the winding connected to earth. Therefore, the defect was not stressed enough for discharges to occur (Illias *et al.* 2012).

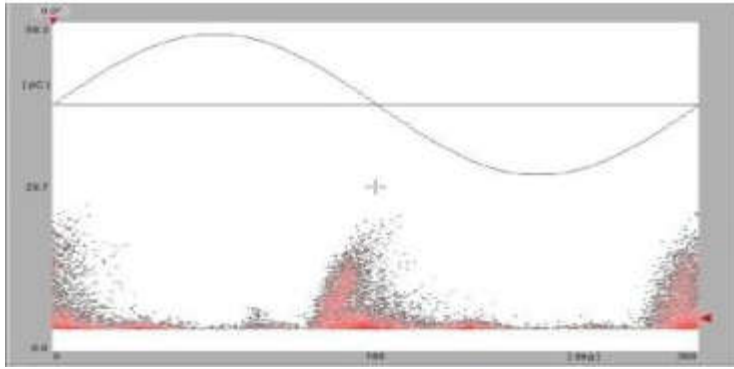
21.2 pC at 15 kV

**Figure19:** Partial discharge pattern measured on an 11 kV VT

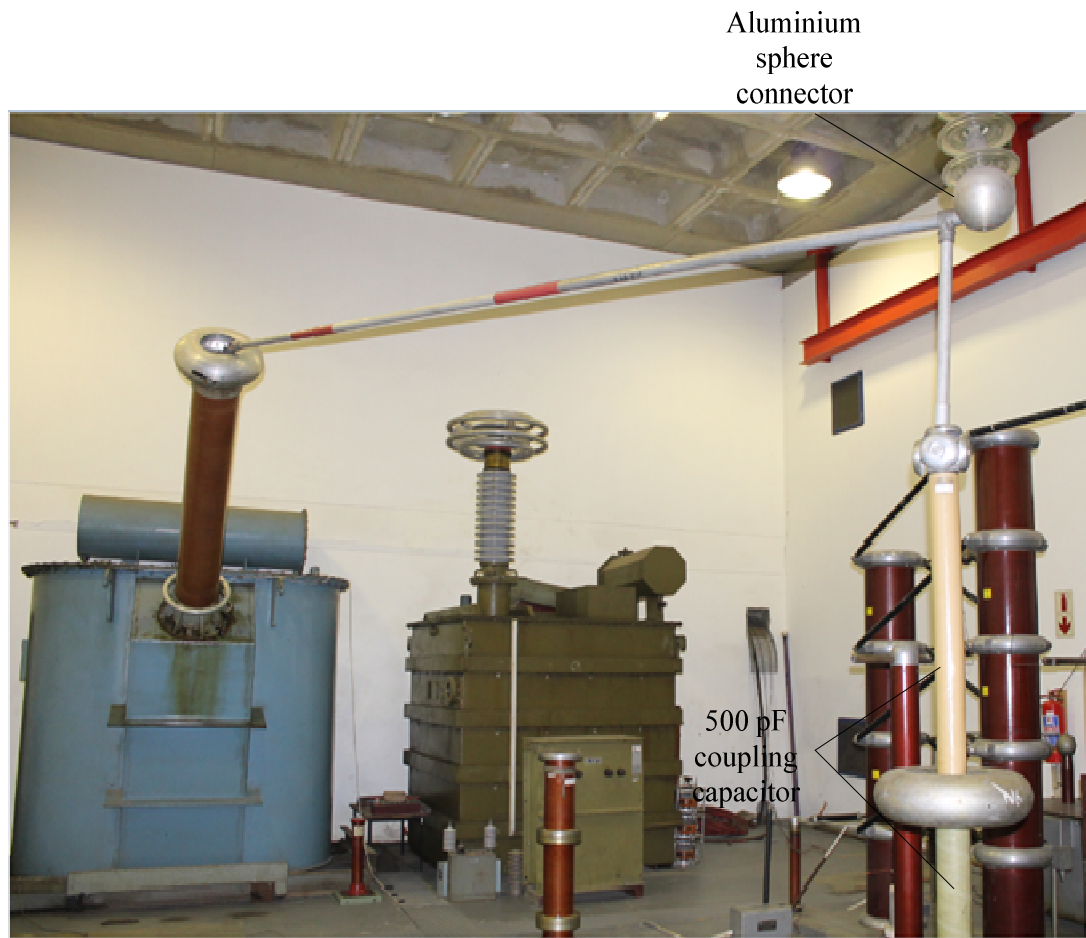
**Figure 31:** Laboratory arrangement of the measuring circuit

The setup was energised and the voltage was increased in steps from 10 kV to 150 kV. Nothing recorded at this stage. The aim was to check the setup to see if the connections were done properly. The voltage was then raised further above 150 kV and continuous corona discharges occurred, which resulted in arcing from the sphere connector. Figure 32 shows the arcs from the sphere.

Since a 300 kV coupling capacitor was not available, two 100 kV coupling capacitors were used as a 500 pF (200 kV) coupling capacitor as shown in Figure 30. After checking if the connection was properly done, the applied voltage was increased from 10 kV to 150 kV and no noise or corona was heard. The voltage increased further above 150 kV and continuous corona discharges occurred, which resulted in arcing from the aluminium sphere as shown in Figure 32.

The setup was rearranged with the aluminium conductor connected from the bushing directly to the 500 pF coupling capacitor as shown in Figure 33. The system was energised and the voltage was then increased in steps from 10 kV to 200 kV.

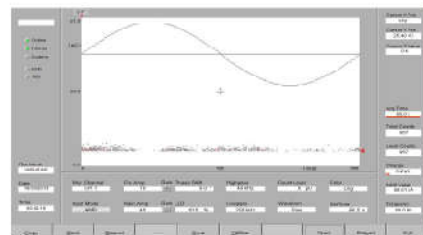
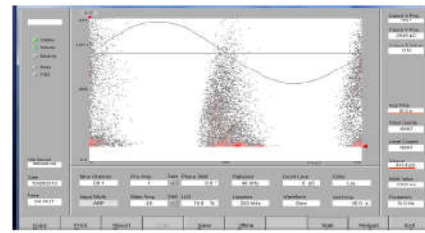
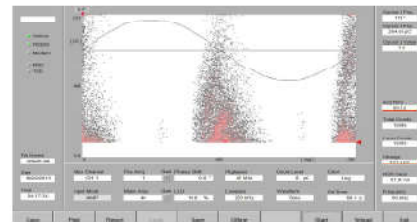
Figure 5: PRPD pattern measured on an 11 kV VT

Figure 5 shows the discharge patterns when the transformer is excited from the high voltage winding as shown in Figure 4. There were no discharges recorded below the knee point voltage of 12 kV as shown in Figure 5(a) and 5(b). Partial discharge activity was only recorded above the knee point voltage as shown in Figure 5(c) and 5(d). The discharges occur at the zero crossings of the applied voltage. One of the possible reasons for the discharges only occurring above the knee-point voltage can be the distortion of the induced voltage when the core is saturated. The peak of the distorted induced voltage will increase as the core goes deeper into saturation. The PRPD pattern seen also indicates that the discharges are not due to a cavity in the insulation but can rather be attributed to surface discharges [2].

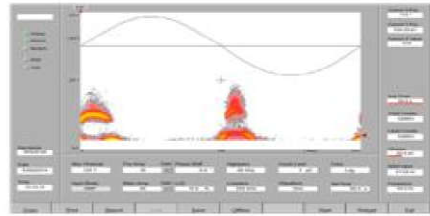
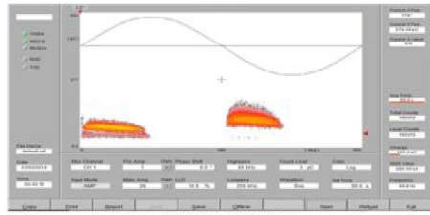
**Figure 3.** PRPD patterns of test samples at 2.5 kV at: (a) 28.4 pC, (b) 22 pC, (c) 165.2 pC

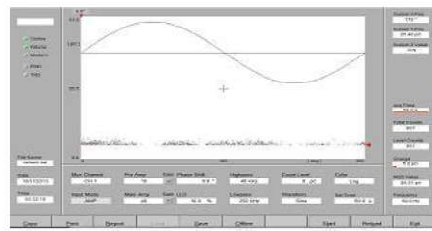
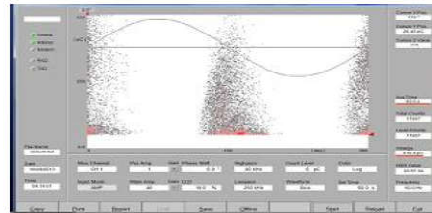
**Figure 7.** PRPD pattern measured on an 11 kV VT: (a) 10 kV at 5.2 pC, (b) 15 kV at 410.4 pC

It was observed from Figure 7 that, no partial discharge was recorded with the applied voltage of 0 – 10 kV which is below the knee point of 12 kV of the voltage transformer as shown in Figure 7 (a). This is because the field intensity within the defect not exceeds beyond the breakdown strength of the gas in defect below the applied voltage of 10 kV. Further increases of applied voltage above the knee point of 15 kV results in partial discharges with higher amplitude as shown in Figure 7 (b). The discharges occur at the zero crossings of the applied voltage. One of the possible reasons for the discharges only occurring above the knee-point voltage can be the distortion of the induced voltage when the core is saturated. The peak of the distorted induced voltage will increase as the core goes deeper into saturation [11]. The PRPD pattern seen also indicates that the discharges are not due to a cavity in the insulation but can rather be attributed to surface discharges [10].

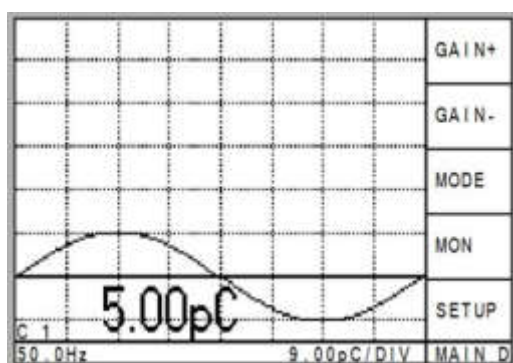
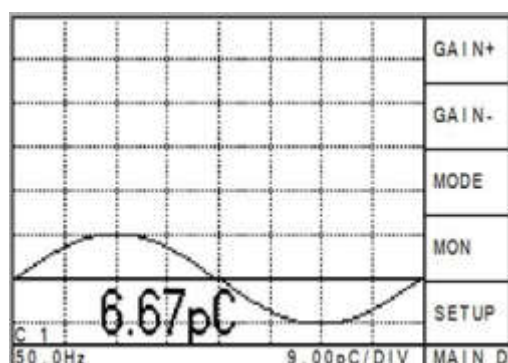
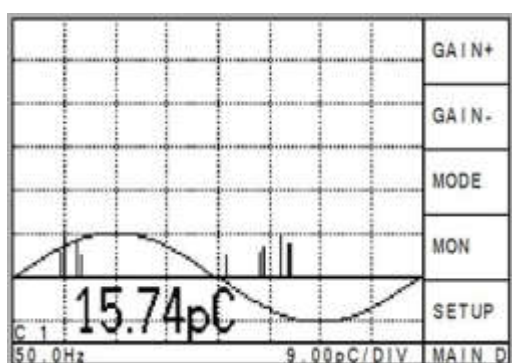
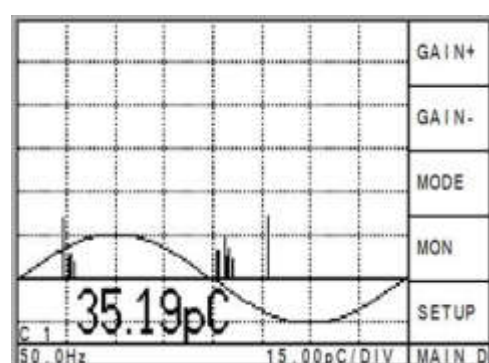
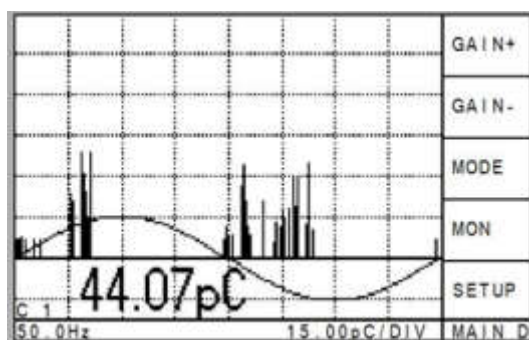
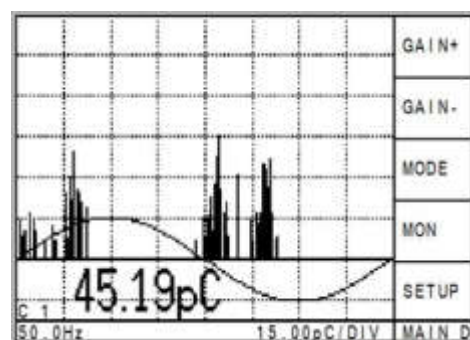
(a) 5,00 pC at 10 kV

(b) 6,67 pC at 20 kV

(c) 15,74 pC at 30 kV

(d) 35,19 pC at 40 kV

(e) 44,07 pC at 50 kV

(f) 45,19 pC at 60 kV

Typical  $\Phi - n$  patterns for a 300 kV transformer .

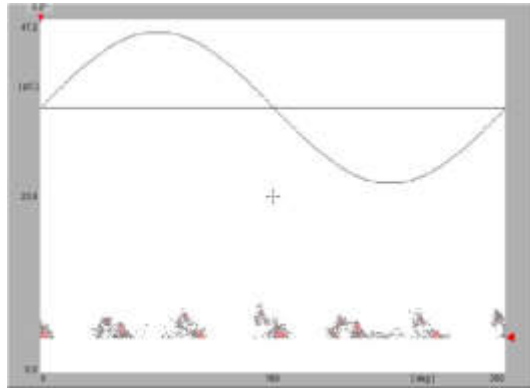
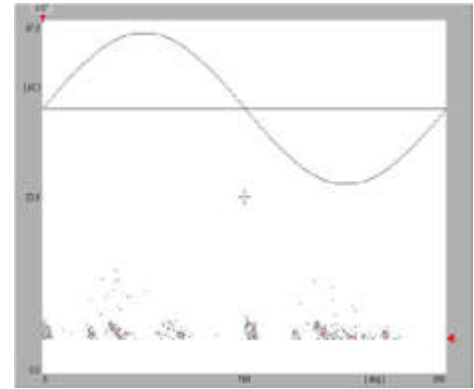
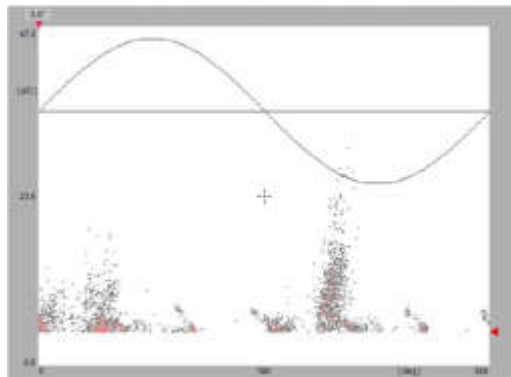
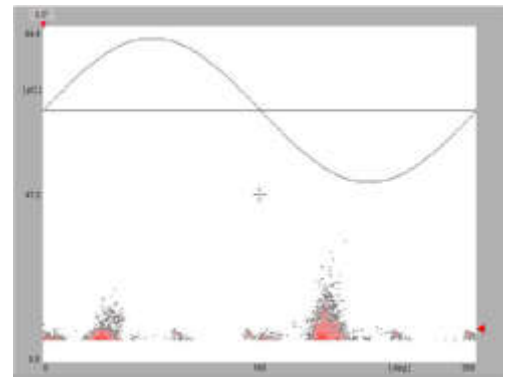
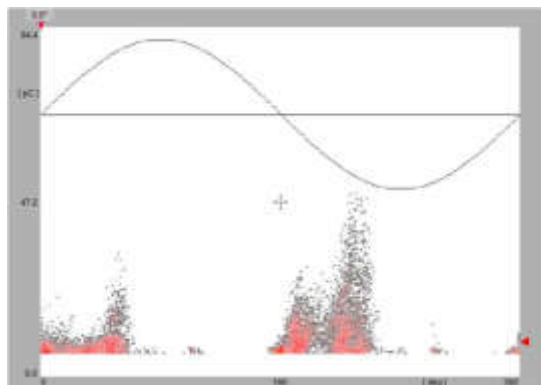
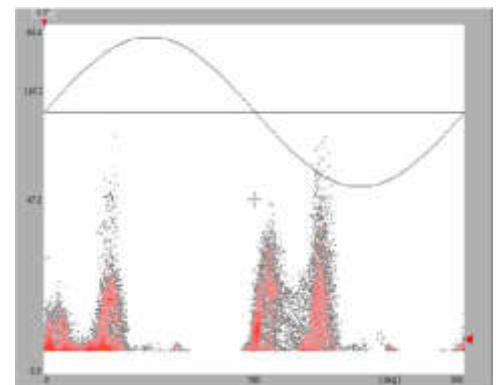
(a) 5,00 pC at 10 kV

(b) 6,67 pC at 20 kV

(c) 15,74 pC at 30 kV

(d) 35,19 pC at 40 kV

(e) 44,07 pC at 50 kV

(f) 45,19 pC at 60 kV

Typical phase resolved PD pattern for 300 kV HV transformer

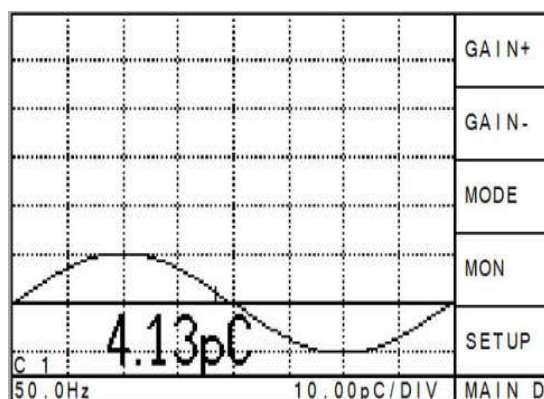
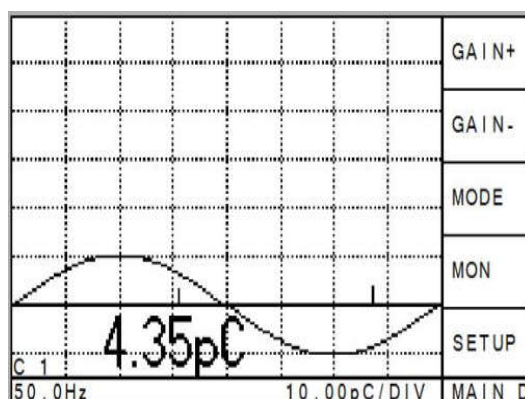
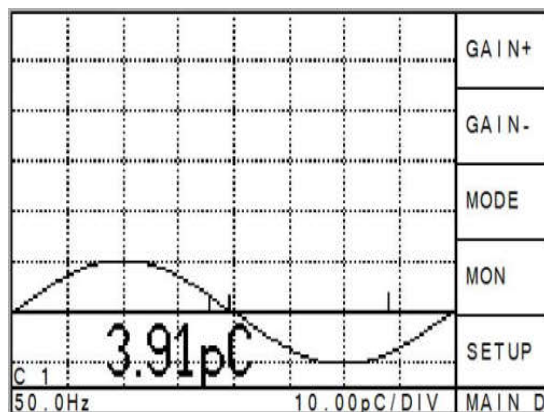
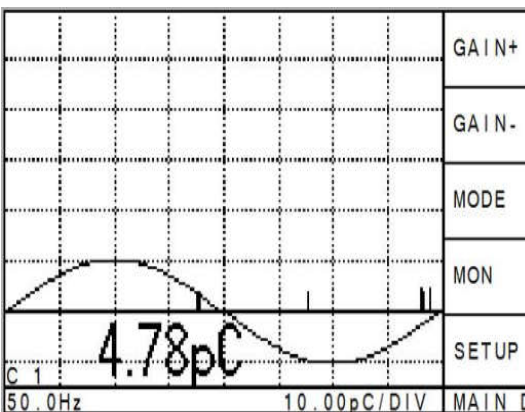
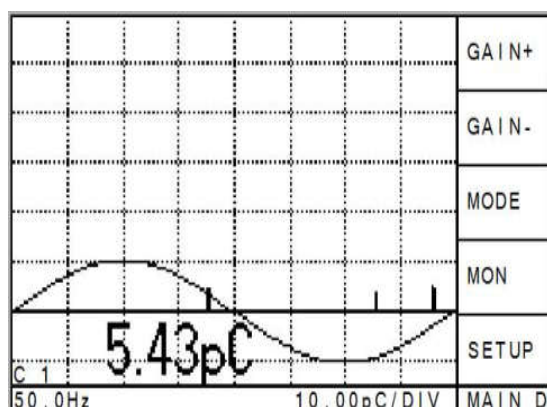
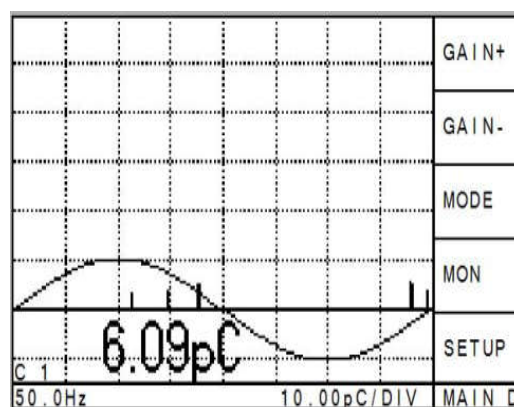
(a) 4,13 pC at 10 kV

(b) 4,35 pC at 20 kV

(c) 3,91pC at 30 kV

(d) 4,78 pC at 40 kV

(e) 5,43 pC at 50 kV

(f) 6,09 pC at 60 kV

Partial discharge pulses recorded from the measurement on a 300 kV transformer.

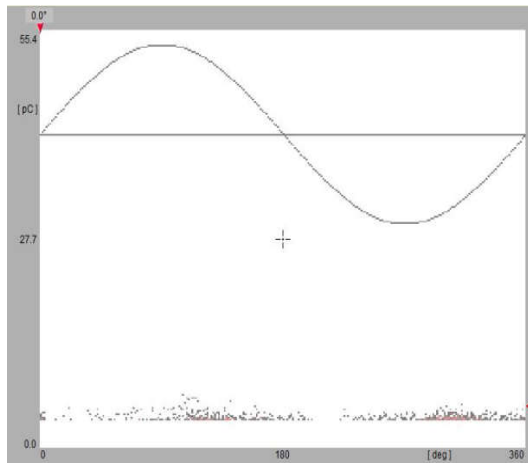
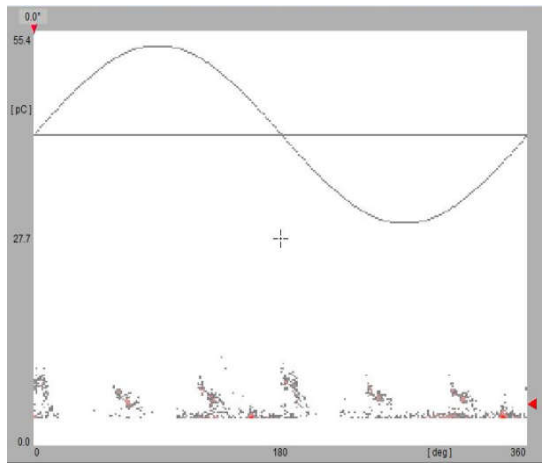
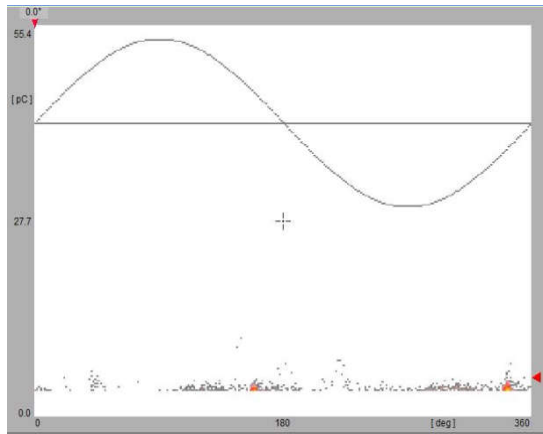
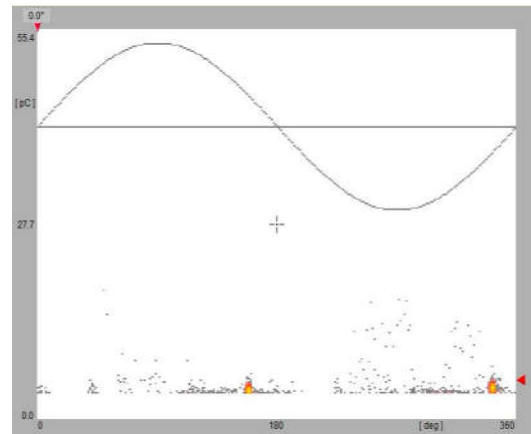
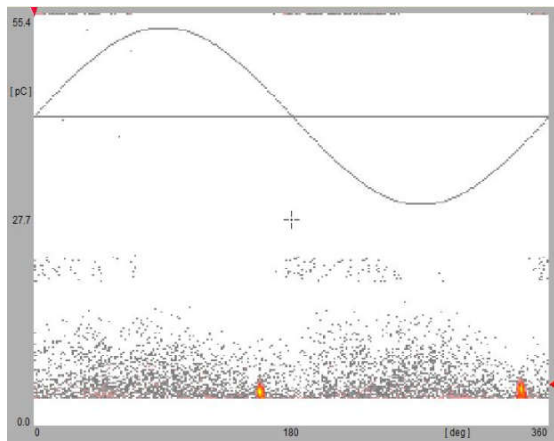
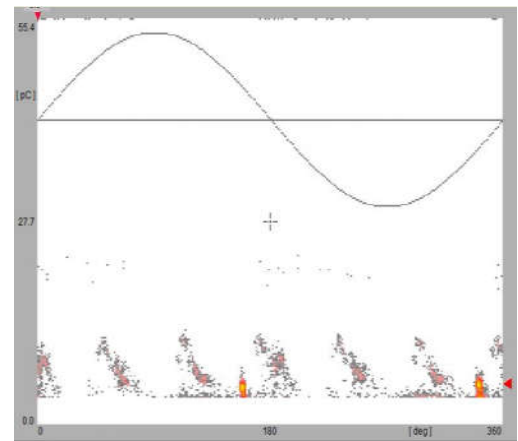
(a) 4,13 pC at 10 kV

(b) 4,35 pC at 20 kV

(c) 3,91pC at 30 kV

(d) 4,78 pC at 40 kV

(e) 5,43 pC at 50 kV

(f) 6,09 pC at 60 kV

PRPD pattern measured on a 300 kV transformer.

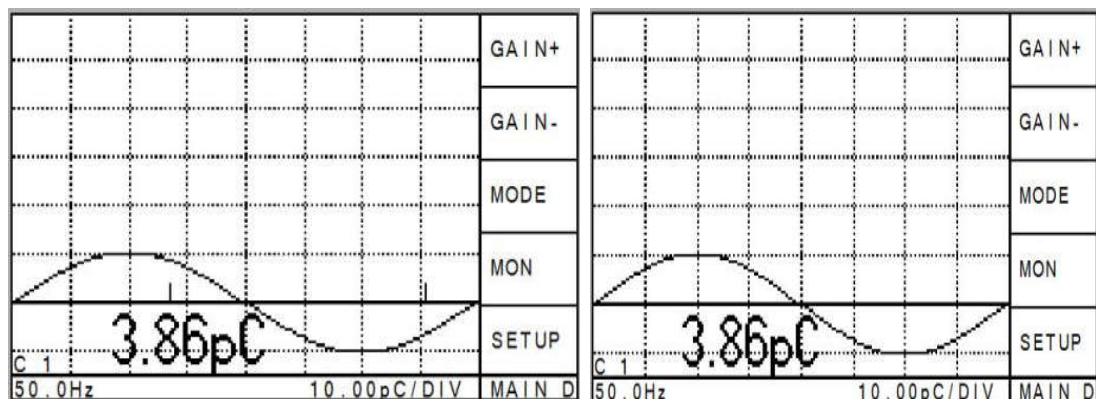
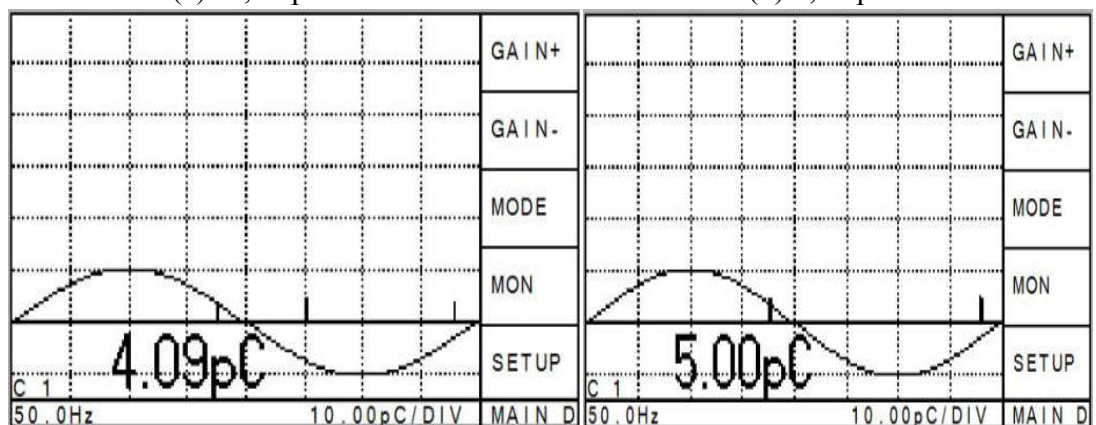
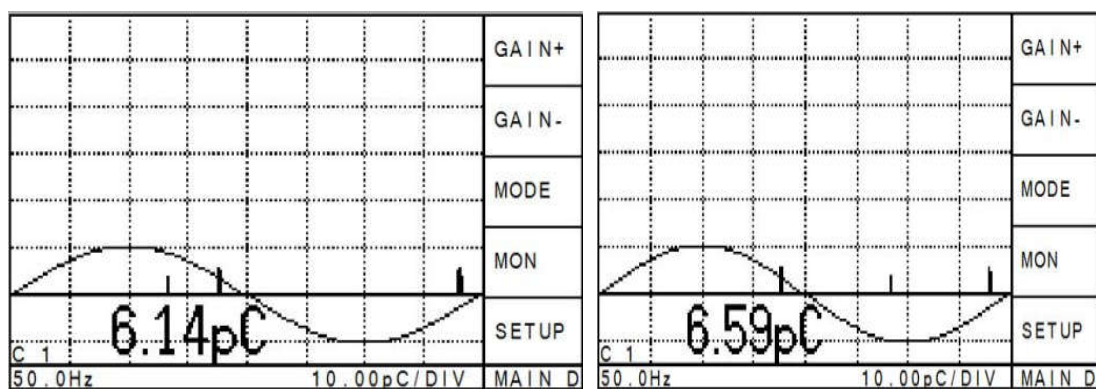
(a) 3,86 pC at 10 kV

(b) 3,86 pC at 20 kV

(c) 4,09 pC at 30 kV

(d) 5,00 pC at 40 kV

(e) 6,14 pC at 50 kV

(f) 6,59 pC at 60 kV

Partial discharge pulses recorded from the measurement on a 300 kV transformer.

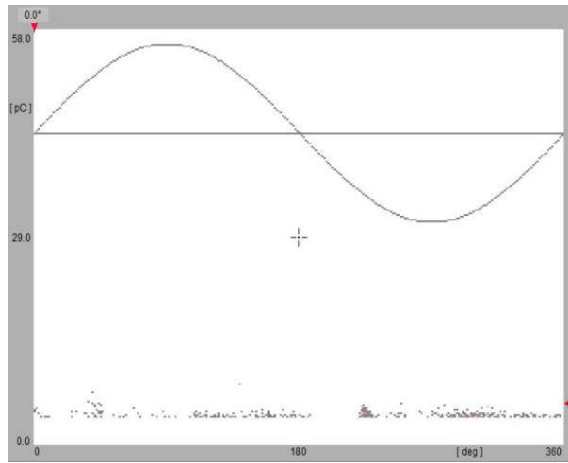
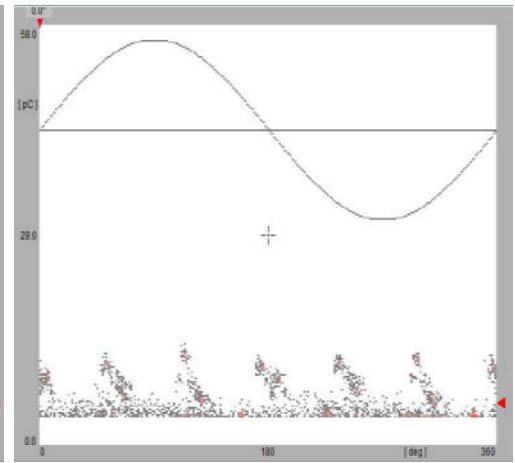
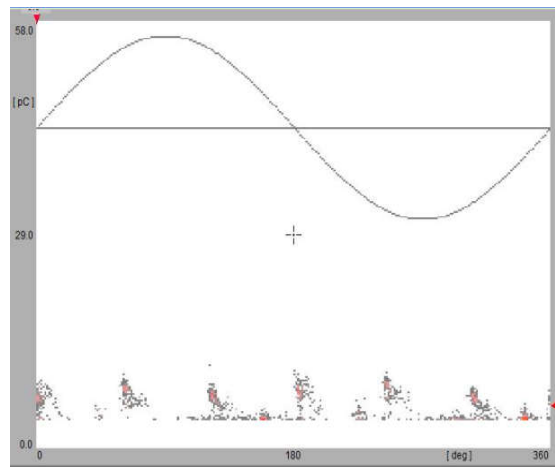
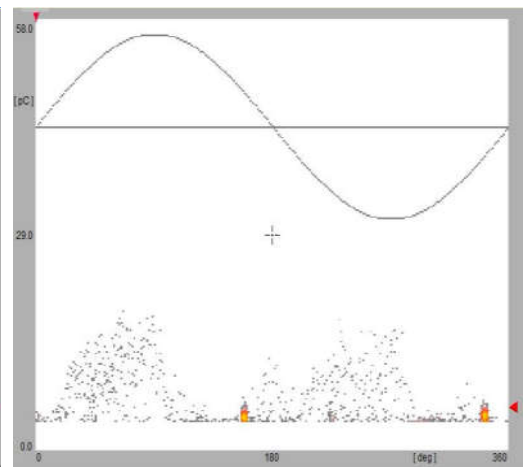
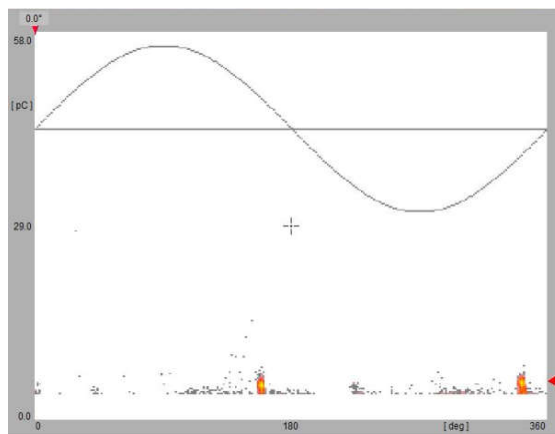
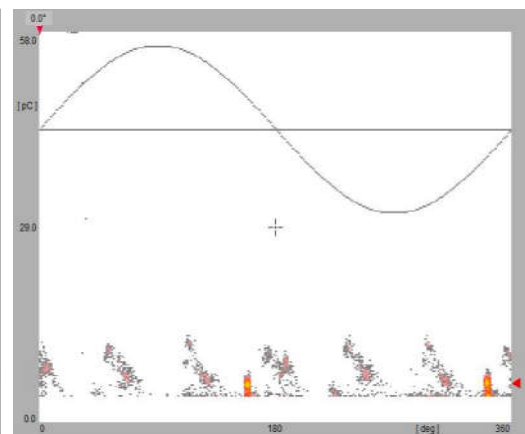
(a) 3,86 pC at 10 kV

(b) 3,86 pC at 20 kV

(c) 4,09 pC at 30 kV

(d) 5,00 pC at 40 kV

(e) 6,14 pC at 50 kV

(f) 6,59 pC at 60 kV

PRPD pattern measured on a 300 kV transformer.

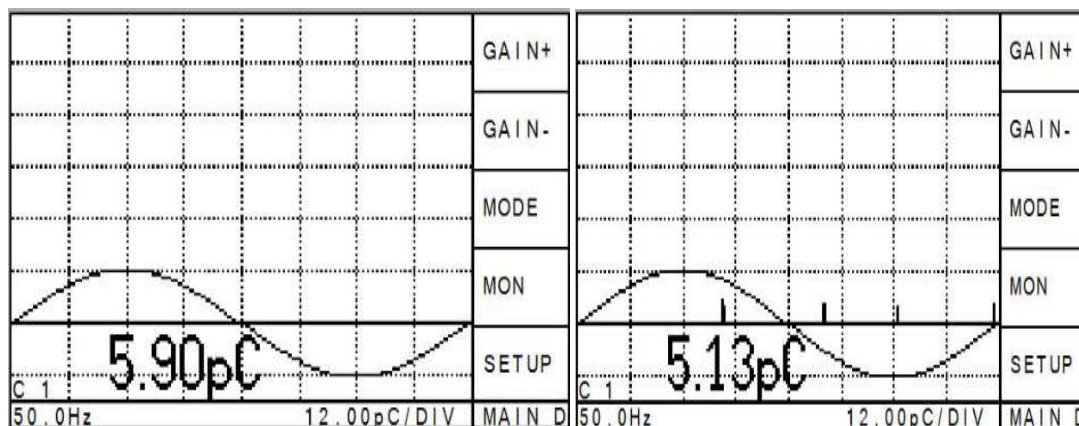
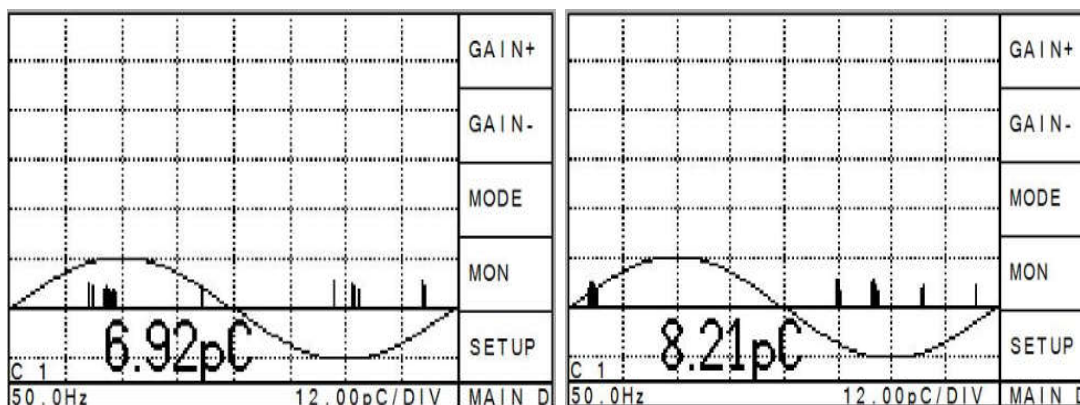
**Annexure I: Partial discharge measurement using 500 pF coupling capacitor (C1+C2) with different setup.**

(a) 5,90 pC at 10 kV

(b) 5,13 pC at 20 kV

(c) 6,92 pC at 30 kV

(d) 8,21 pC at 40 kV
